INDOOR AIR QUALITY ASSESSMENT

Manomet Elementary School 70 Manomet Point Road Plymouth, MA 02360

Prepared by:
Massachusetts Department of Public Health
Center for Environmental Health
Emergency Response/Indoor Air Quality Program
August 2005

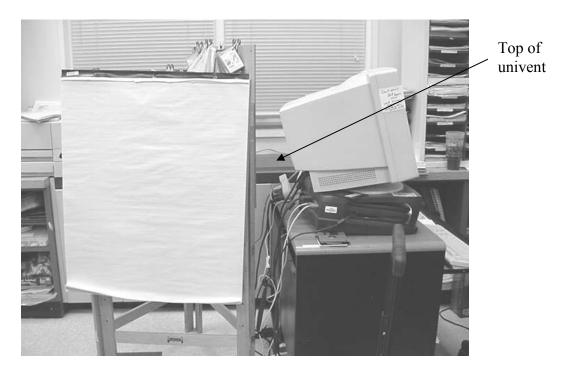
univents, were also observed despite signs advising against such practices (Pictures 1 and 2). To function as designed, univents must be allowed to operate and remain free of obstructions.

Univent located between desk and easel

- 6. Remove all obstructions from univents and exhaust vents to facilitate airflow. Close classroom doors to improve air exchange.
- 7. Remove debris and dust accumulated on ventilation grilles.

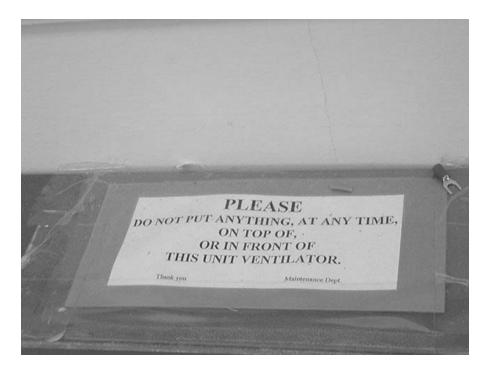
Sign advising against placing materials on univent

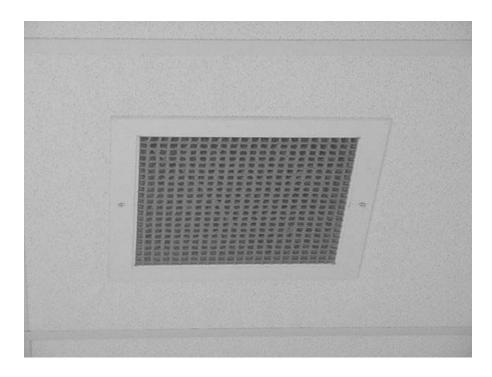
Exhaust ventilation is provided by ceiling-mounted or closet vents (Pictures 3 and 4), which are ducted to motorized fan units on the roof. For rooms with closet exhausts, classroom air is drawn through a space beneath the closet door and into the closet (Picture 5). The exhaust vents located in the upper portions of the coat closets exhaust air. However, closet exhaust vents are prone to obstruction by items placed in front of floor level openings and/or on shelves below the vent. In addition, several ceiling-mounted vents are located near hallway doors (Picture 6). When classroom doors are open, exhaust vents for these rooms will tend to draw air from both the hallway and the classroom, reducing the effectiveness of the exhaust vent to remove common environmental pollutants. As with the univents, in order to function properly, exhaust vents must be activated and remain free of obstructions.

Ceiling exhaust vent, note dust

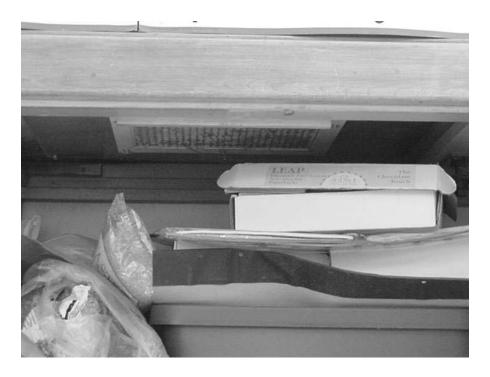
Closet exhaust vent, note dust occluding vent and materials stored below vent

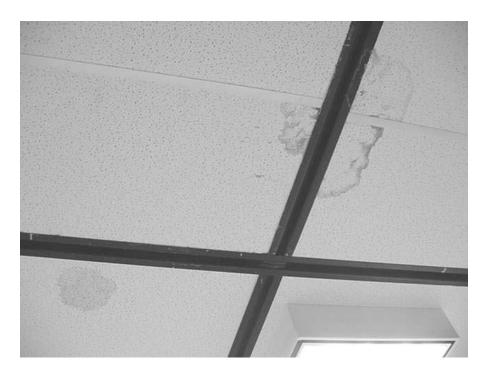
All classrooms in the portable wing had water-damaged ceiling tiles (Picture 8). Water-damaged ceiling tiles can provide a source for mold growth and should be replaced after a water leak is discovered and repaired. Appropriate measures should also be taken to minimize the aerosolization of particulates from tile removal/replacement.

Water-damaged ceiling tiles

- 9. Identify and repair sources of water leaks. Replace water-damaged ceiling tiles. These ceiling tiles can be a source of microbial growth. Examine the non-porous surface beneath the removed ceiling tiles and disinfect with an appropriate antimicrobial.

Appropriate measures should also be taken to minimize the aerosolization of particulates from tile removal/replacement.
- 10. Examine and repair rubber window gaskets to prevent water intrusion.
- 11. Seal seams between sink countertops and backsplashes to prevent water damage.
- 12. Examine plant water catch basins for mold growth. Disinfect water catch basins if necessary. Remove plants from in close proximity to ventilation sources.
- 13. Relocate or consider reducing the amount of materials stored in classrooms to allow for more thorough cleaning of classrooms. Clean items regularly with a wet cloth or sponge to prevent excessive dust build-up.
- 14. Consider discontinuing the use of tennis balls on chairs to prevent latex dust generation.

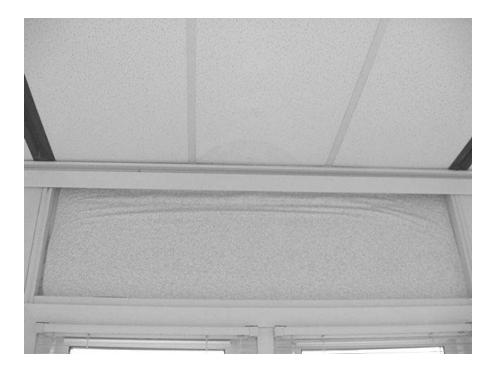
Wallpaper-like material above windows in the portable classrooms was observed to be loose (Picture 9). This is an indication that water is penetrating from the exterior and moistening the wallpaper-like material. As with water-damaged ceiling tiles, water damaged porous materials can be a source for mold growth. In addition, wallpaper layers can trap other materials that can be a source for mold growth. Water-damaged wallpaper should be removed to prevent potential mold growth in/on building materials. Materials behind the wallpaper should also be examined.

Water-damaged porous material

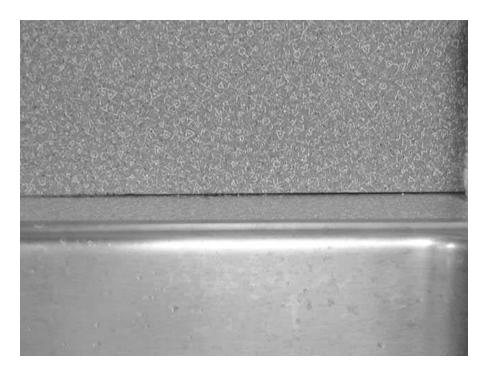
Spaces between the sink countertop and backsplash were seen in several areas (Picture 10). Improper drainage or sink overflow can lead to water penetration into the countertop,

cabinet interior and areas behind cabinets. If these materials become wet repeatedly they can provide a medium for mold growth.

Space between sink countertop and backsplash

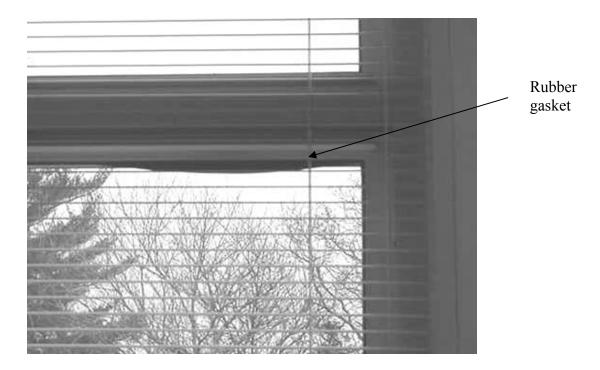
A number of other conditions observed along the building exterior may be conducive to water penetration through the building envelope. Breaches were noted in and around the building and its windows. A rubber gasket for a classroom window was also failing (Picture 11). These breaches can serve as points for water entry into the building. Continued freezing and thawing of water during winter months will serve only to further damage the foundation. In addition, breaches can serve as points of entry or shelter for pests.

Failing rubber gasket in window

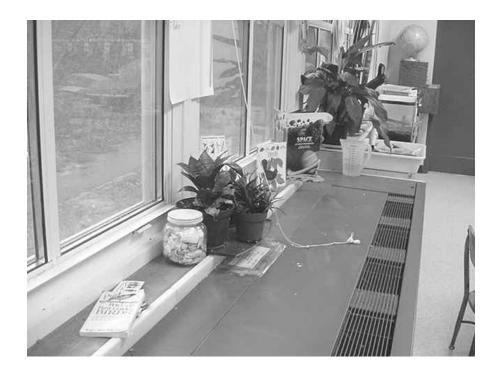
Plants were noted in several classrooms. Plants should be properly maintained and equipped with drip pans. Some plants were placed near ventilation sources (Picture 12). Plants can be a source of pollen and mold, which can be respiratory irritants for some individuals. Plants should be located away from univent air diffusers to prevent the aerosolization of dirt, pollen or mold.

Plants near univent, note dust on top of univent

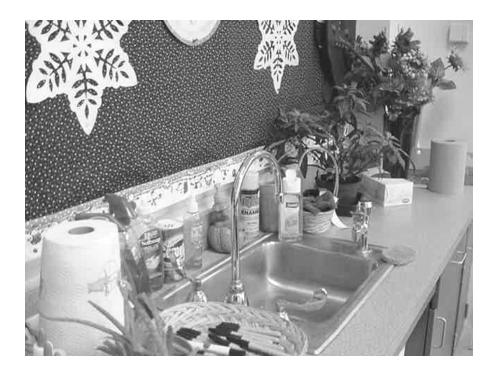
A number of cleaning agents were also observed in classrooms (Picture 14). Like dry erase materials, cleaning products contain VOCs and other chemicals that can be irritating to the eyes, nose and throat of sensitive individuals. Also of concern are unlabelled bottles and containers. Products should be kept in their original containers and be clearly labeled for identification purposes, especially in the event of an emergency.

Cleaning products

- 15. Clean chalkboard/dry erase marker trays regularly to prevent the build-up of excessive chalk dust and particulates.
- 16. Store cleaning products properly and out of reach of students. Ensure bottles are properly labeled in the case of emergency.
- 17. Refrain from using food containers as materials for projects.
- 18. Consider adopting the US EPA document, *Tools for Schools* (US EPA, 2000b), as a means for maintaining a good indoor air quality environment in the building. This document can be downloaded from the Internet at http://www.epa.gov/iaq/schools/index.html.
- 19. Refer to resource manuals and other related indoor air quality documents for further building-wide evaluations and advice on maintaining public buildings. Copies of these materials are located on the MDPH's website: http://mass.gov/dph/indoor air

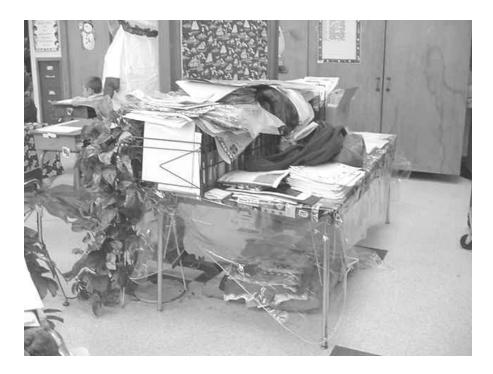
In several classrooms, items were observed on windowsills, tabletops, counters, bookcases and desks (Picture 15). The large number of items stored in classrooms provides a source for dusts to accumulate. These items (e.g., papers, folders, boxes) make it difficult for custodial staff to clean. Items should be relocated and/or be cleaned periodically to avoid excessive dust build up.

Storage of items

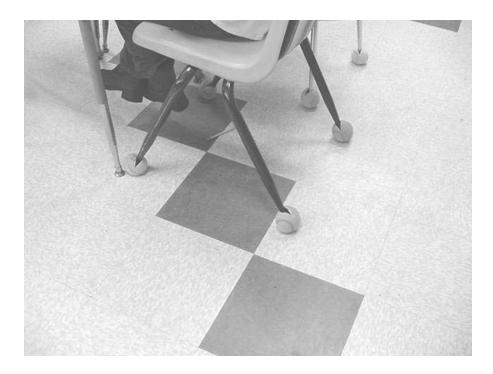
In an effort to reduce noise from sliding chairs, tennis balls had been sliced open and placed on chair legs (Picture 16). Tennis balls are made of a number of materials that are a

TVOCs to off-gas. Tennis balls are made with a natural rubber latex bladder, which becomes abraded when used as a chair leg pad. Use of tennis balls in this manner may introduce latex dust into the school environment. Some individuals are highly allergic to latex (e.g., spina bifida patients) (SBAA, 2001). It is recommended that the use of materials containing latex be limited in buildings to reduce the likelihood of symptoms in sensitive individuals (NIOSH, 1997). A question and answer sheet concerning latex allergy is attached as Appendix B (NIOSH, 1998). Consider replacing tennis balls with alternative glides (Picture 17).

Tennis balls on chair legs

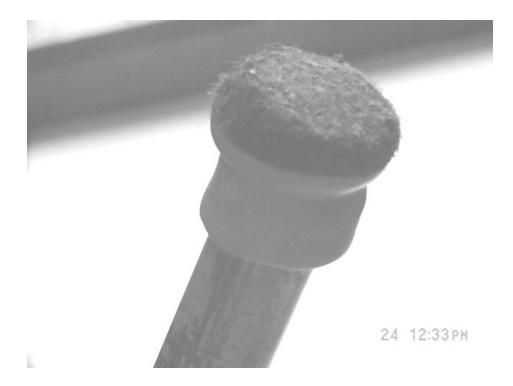
Alternative 'glides' for chair legs
